## MAINTENANCE AND SERVICES

# THE SPANISH EXPERIENCE ON-LINE FUEL INSPECTION AND REPAIR

R. SANSA - M. MARTIN - E. CASTAÑOS

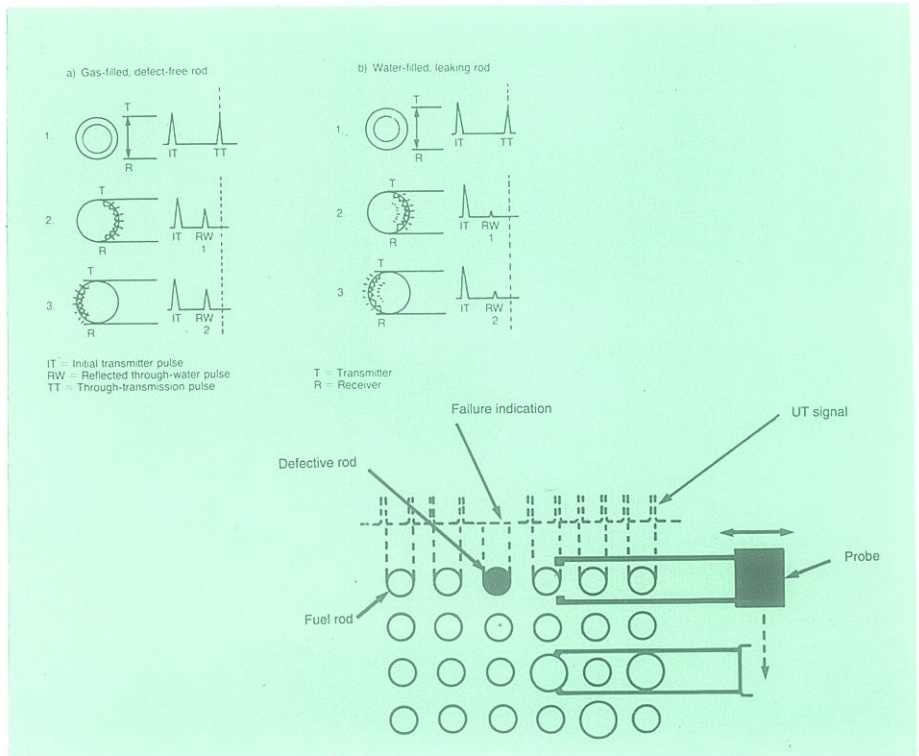
**FI** UT Inspection Method.

The presence of water inside a rod will cause the received signal to diminish or disappear, which will indicate a failure or defect in the rod (Figure I).

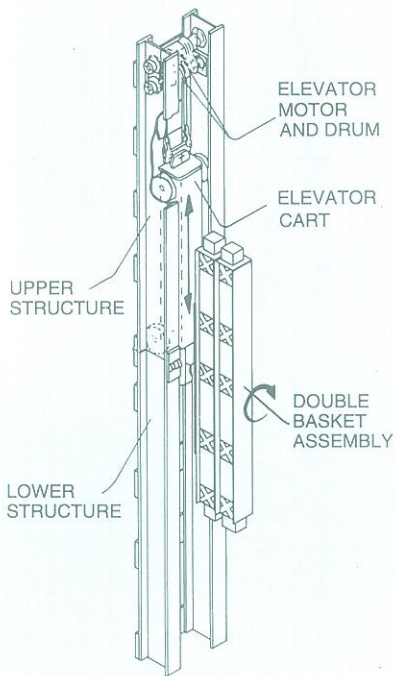
## F V Multi-Purpose Fuel Repair System, MFRS

The MFRS system is basically composed of the following components (Figure V):

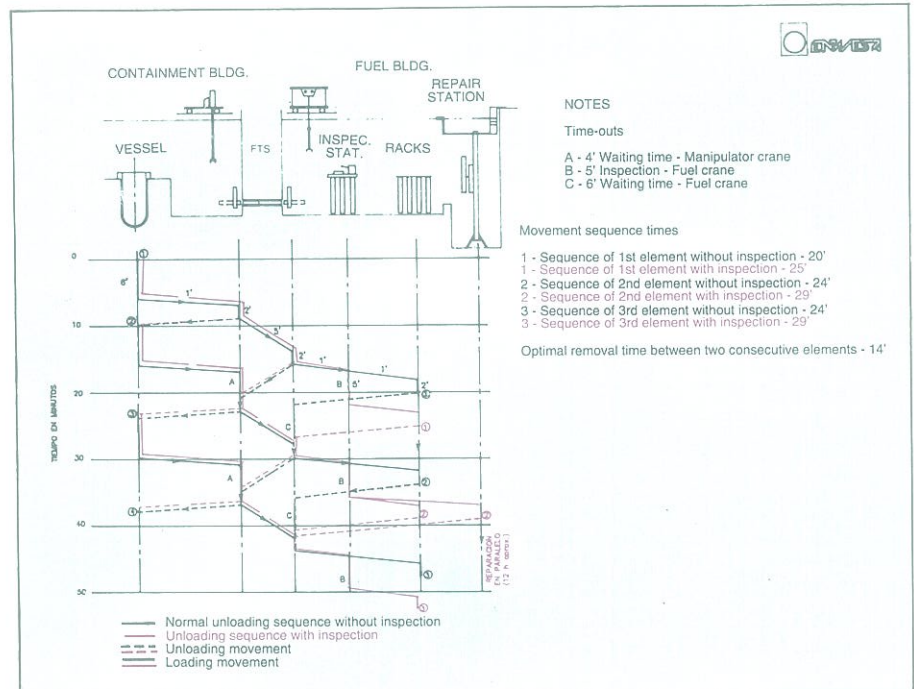
## F VI Operating Sequence - Fuel Unloading

In the feasibility study, the different operations in the fuel unloading process were timed to verify the impact of fuel inspection on the total unloading time (Figure VI).

As shown in the diagram, since inspection takes only a short time to perform (5 minutes), no delays are caused in the total unloading time of each element (15-20 minutes); the critical path in the unloading process is the time spent by the fuel element in the transfer channel. Once it was verified that inspection was

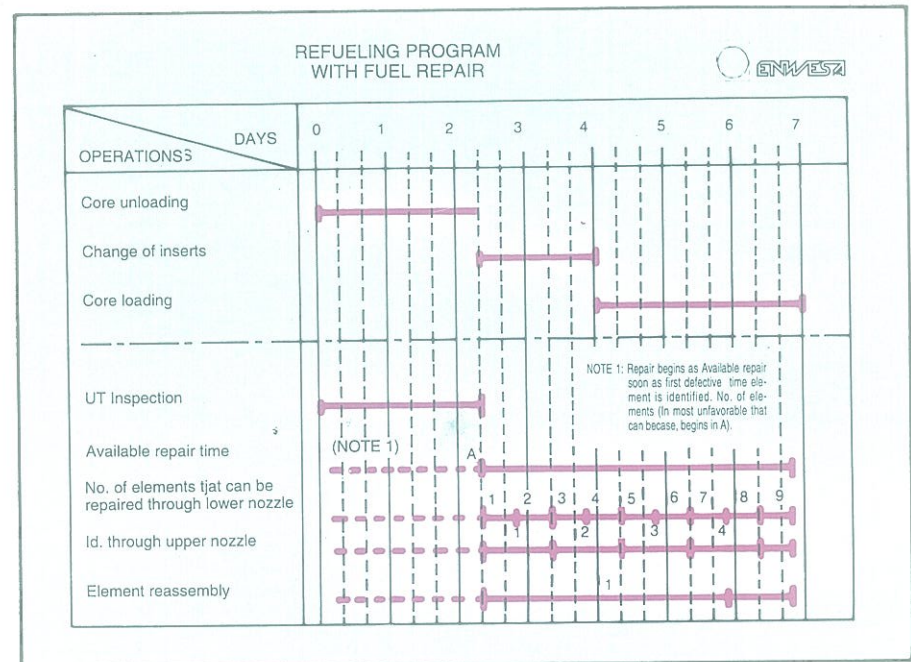
## F VII Fuel Repair Program

With these data and on the basis of an optimal refueling program, we would obtain the graph shown in Figure VII.

In the most unfavorable case, a total of 9 elements can be reconstituted without interfering with the refueling program. It is extremely rare for this number of defective elements to appear in a single operating cycle, unless caused by something atypical such as baffle jetting. It must be noted that in actual scheduling, some waiting times are scheduled between unloading and loading to core due to maintenance work; they are not reflected in this program because, as mentioned above, it is considered to be an optimal program.
