# REMOVE FOULING IN THE NATURAL DRAUGHT COOLING TOWERS

The main aim of this project was to eliminate and remove all fouling and scale (mainly calcium carbonate) that had accumulated in the internal water distribution system of the two N71 system towers (N71DD104A “East Tower” / N71DD104B “West Tower”).

The aim of this article is to describe the procedure to remove fouling in the N71 natural draught cooling towers during Refuelling Outage 22 at Cofrentes NPP. It outlines the tasks performed, the person-hours employed, the procedures followed and the proposals for improvement.

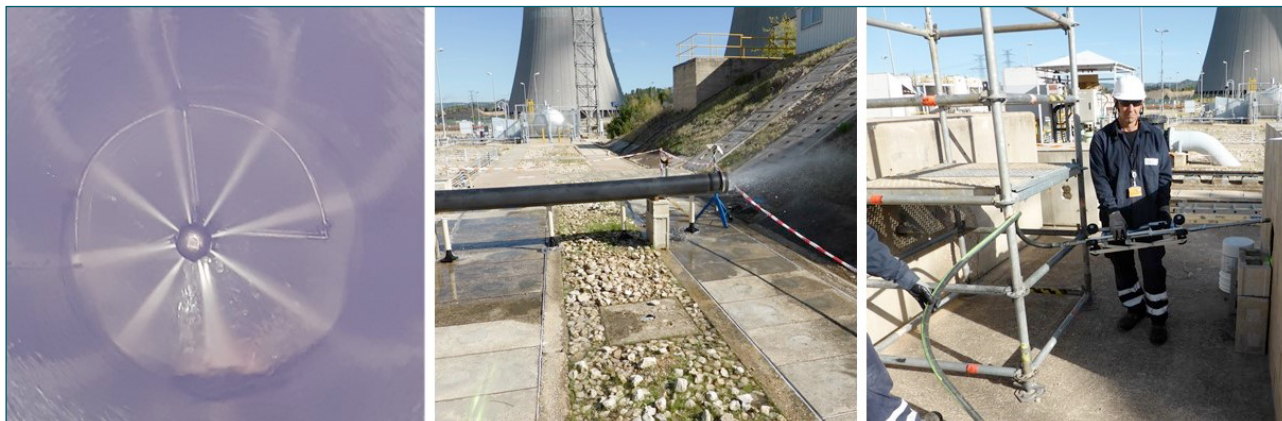
**Figure 1.** Various images from the validation phase.

Figure 1 shows different images of the validation phase. The various proposed solutions were tested on the model in a process of elimination, and the most significant parameters were fine-tuned. Next, tests on the scaling and fouling to be removed were carried out on the real towers in operation.

Various images of the validation phase are shown in Figure 1. The various proposed solutions were tested on the model in a process of elimination, and the most significant parameters were fine-tuned. And, once the process had been fine-tuned, tests on the scaling and fouling to be removed were carried out on the real towers in operation.

A 1:1 scale model of a typical tower section was designed for the purpose of validating the agreed solution, and to determine the operating parameters and times required. This model contained the essential parts: flumes, DN250 PVC pipes and real nozzles.

Finally, and in order to optimise the procedure that yielded the best results in the tests, it was concluded that the most efficient solution was a rotating nozzle made-to-measure for the dimensions and properties of the task. The requisite materials were procured, and the method and performance parameters were validated, enabling the operation to be scheduled for completion within the planned refuelling outage time.

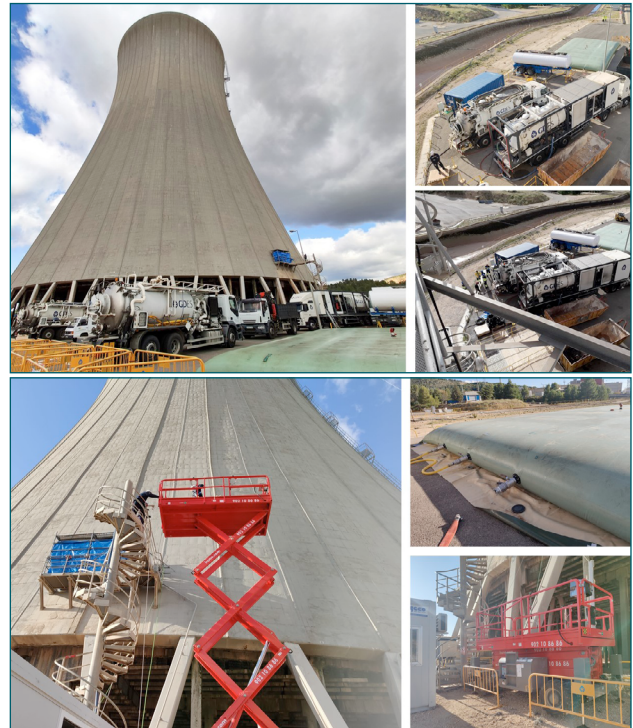
Figures 3 and 4. Various images of the external set up.

Figures 3 and 4 show different moments in the setting up of the equipment on the outside of the towers.

As shown in Figures 3 and 4, two skips were located near the West Tower and one near the East Tower (in places easily accessible to vehicles for loading and unloading).

A lifting platform was placed alongside the tower being serviced to bring materials in and out, and another lifting platform was placed under this same tower as an emergency measure in the event of an accident. These platforms were moved from one tower to another as work was performed on one or the other.

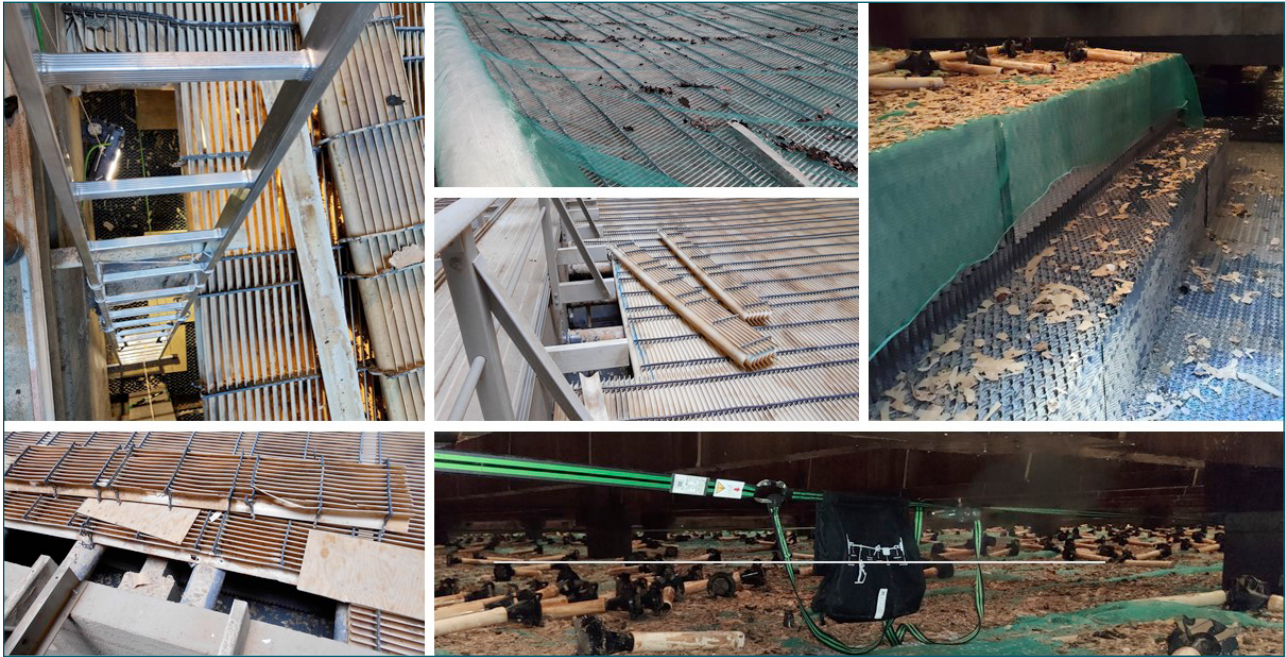
Figure 5. Various images of the internal set up.

Figure 5 shows different images of the set up inside the towers.

- **Removal of the drift eliminators.** As these form the upper part of the entire spray, water and fill system, certain sections had to be removed to gain access to the system.

- **Installation of ladders to access the space between the fill and the drift eliminators**, where the nozzles to be removed are located.
- **Installation of lifelines and weight distribution platforms.** In order to be able to walk across the fill packs and access the nozzles, it is first necessary to install lifelines and then to install weight-distributing boards to distribute the weight when walking.

- **Installation of nets on the fill media** to protect against falling nozzles and waste.
- **Installation of nets to catch algae** in Sectors 1 and 2 of the towers. When the towers are shut down, the algae that have grown on the inner walls of the towers during the operating cycle die and fall on the operators working below. It is therefore essential to install nets in the main sectors.

- **Protection of inlet connections from the flumes.** It is essential to close the inlets through which water enters the distribution system of the towers to prevent anyone from falling through them.

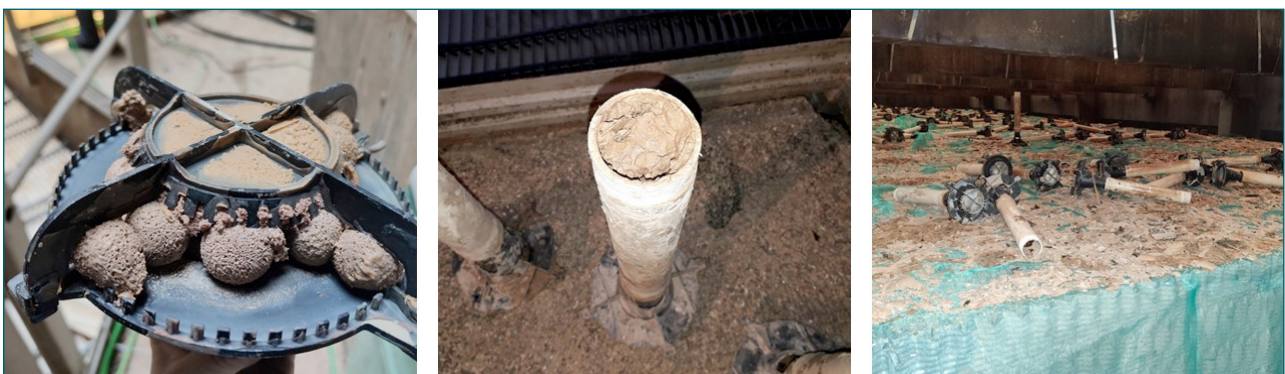
Figure 6. Preliminary condition of nozzles.

Under normal conditions, the nozzles are removed by hand, but limescale build-up on the threads prevented this method (Figure 6). The solution was to use pipe wrenches.

The nozzles were cleaned either manually, in dry conditions, to remove the calcium carbonate, or by flushing with water when they were additionally clogged with mud and/or Taprogge® balls.

Once the nozzles were removed and cleaned, they were inspected and the defective ones were replaced.

Some nozzles had to be repaired at the base as part of the DN250 PVC pipe that they were screwed into had broken. In some cases, the nozzles with an intact length of PVC pipe were used, and in other cases, a new coupling was used.

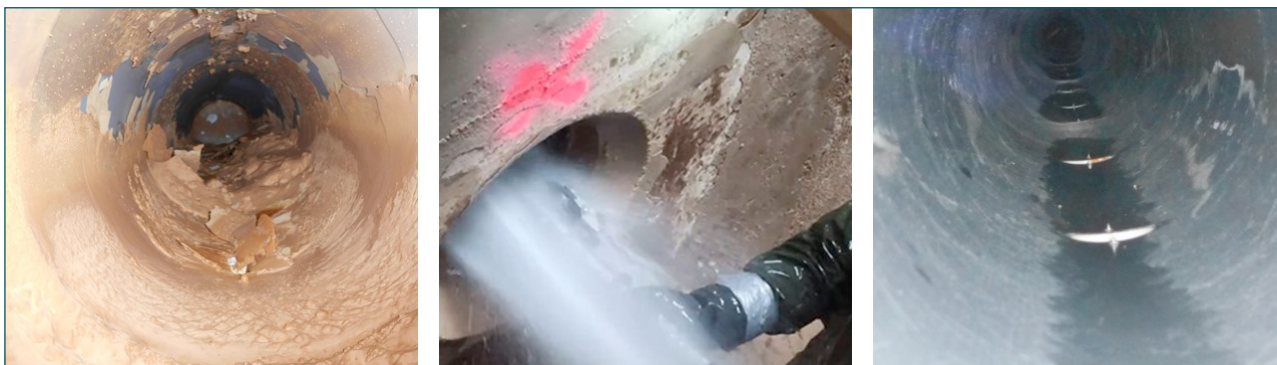
Figure 7. Initial state of pipes, cleaning process and final state.

The incrustations were removed from the inside of the pipes using a specific tool for cleaning pipes with high-pressure water, working with a GHD Truck at 200 bar (Figure 7). To do this, access was gained from the water distribution flume, one by one, to the intake of each of the pipes.

100% of the inside of the pipes were cleaned. A key factor in this was the determination of flow rate, spray times and nozzle rotation speed in the preliminary tests. As a result, cleaning was optimised, resulting in a high percentage of work performed in a single pass, and the process could be repeated in pipes with larger accumulations of scale and fouling that could not be removed with a single pass, without affecting the planned execution times.

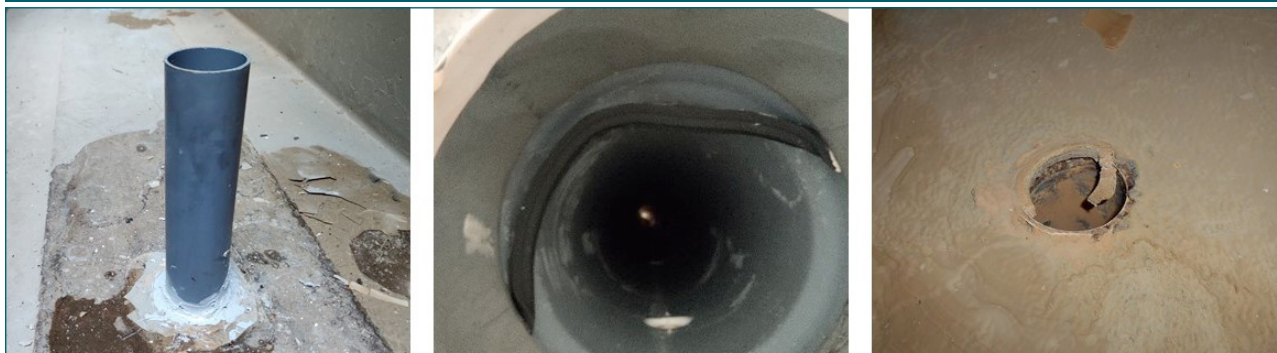
Figure 9. Images of other maintenance activities.

The rubber seals of the DN250 PVC pipes (only where necessary) were repaired by cutting off the protruding part of the seals and applying a sealant (Figure 9).

All the nozzle tubes embedded in the flumes were repositioned and sealed.

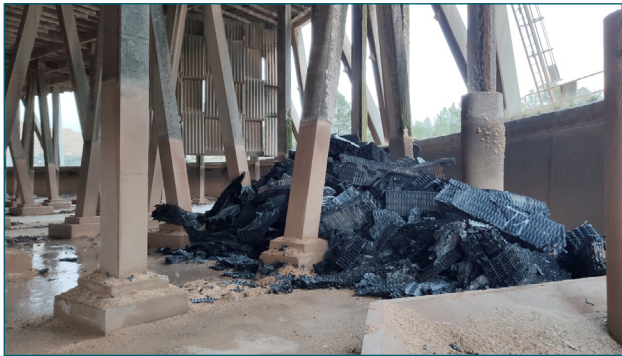
**Figure 10.** Removal of the fill packs.

To remove the discarded fill from the inside of the tower basins (Figure 10), one small loader (Gehl®) and two large loaders (Manitou®) were used.
